## **JOINT VENTURE (HSV-X1)**

### **TRANSPORTABILITY ANALYSIS OF VESSEL LOADING DURING MILLENNIUM CHALLENGE 2002**

**Port Hueneme, California, to Port of Tacoma, Washington  
(11 Thru 13 August 2002)**

**29 OCTOBER 2002**

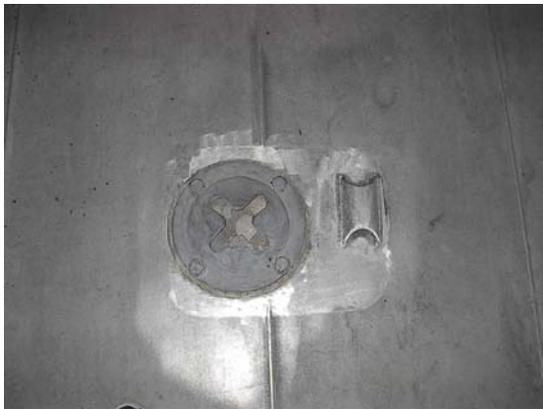
Figure 3. Peck and Hale Cloverleaf (New)

e. Lashing. Once the vehicles were loaded, military stevedores started lashing operations. Vehicles were lashed to existing deck tiedowns and the newly added Peck and Hale (P&H) cloverleaves (fig 3) that are rated @ 6.5 tons each and spaced 27.5 feet longitudinally and 10' laterally apart. Lashing gear consisted of 1-ton and 2.5-ton cargo straps, 1.75-ton and 4.25-ton P&H chain gripes. The vehicles were lashed to only a few of the newly added P&H cloverleaves. Most of the vehicles were lashed to the original vessel tiedown tubes (figs 4 and 5) that are rated for .8 tonne (1,764 lbs) axle load cars only.

Approximately 39 P&H raised cloverleaves were added to the deck of this vessel to accommodate tiedown of large vehicles. Vehicles were lashed to the existing vessel tiedown tubes and most of the P&H cloverleaves were not used during this exercise. The P&H cloverleaves are situated on the deck so that the Strykers could have been positioned between them.

These cloverleaves should be flush with the deck and the tube tiedowns should be replaced with stronger fittings to avoid damage to the vehicles and the vessel. Fittings should be placed on a 4' x 4' grid throughout the cargo area.

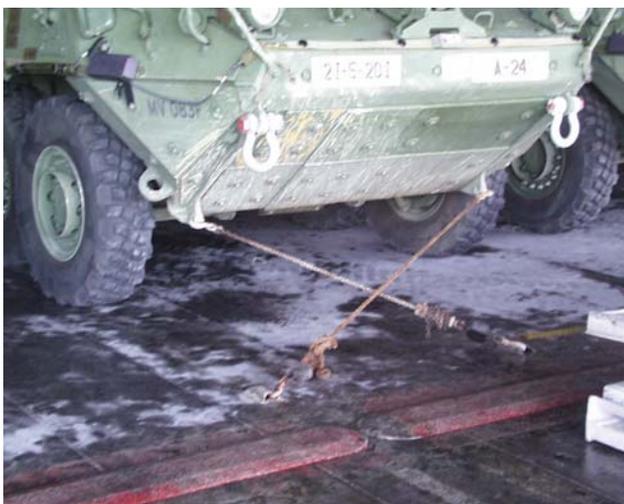
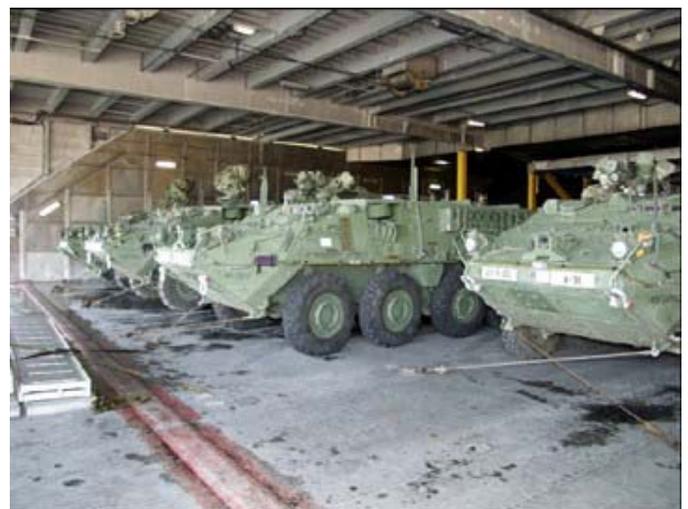
Figure 5. Strykers Lashed to Vessel Tiedown Tubes

The lashing restraints were not sufficient in strength for this type of load. During the ocean transit to Port of Tacoma, rough seas caused the HSV-X1 to slam violently inducing vertical cargo movements. A minimum requirement for the Stryker should be eight 35K P&H restraints with rubber snubbers to absorb the shock load.

These vessels should be instrumented to determine the type of G forces that will be encountered by the vehicles being transported at various sea states. This will assist in determining the appropriate strength requirement for cargo restraints and deck fittings. Pending collection of this data, recommend lashings have the capacity to restrain the cargo to a minimum of 1G.

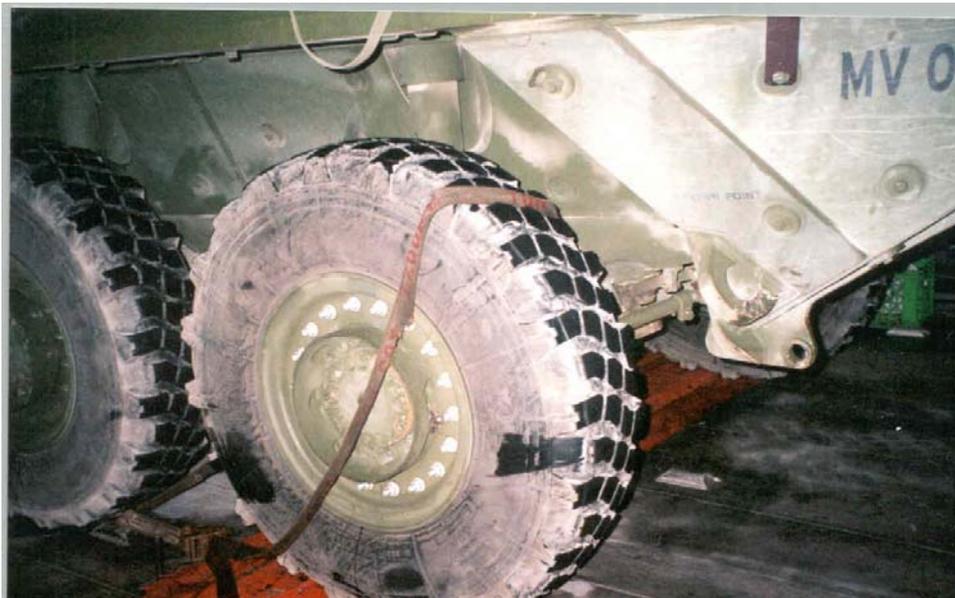
Figure 6. Straps Added to Stryker Tires

b. During the transit, rough seas with approximately 9- to 12-foot waves (Sea State 5) were encountered. When MTMCTEA engineer, John Atwood, entered the cargo area to observe the effect of the high seas on the equipment, he noticed that the Strykers started to bounce and move back towards the aft end of the vessel. The impact of the vessel slamming caused the suspension systems of the Strykers to bottom out causing these vehicles to move in a violent vertical motion. This movement caused the lashing gear to become very loose on the downward motion of the vehicle and during this time they slid on the wet deck. Some of these vehicles moved approximately 1' from their original stow location. The military stevedores and other ship personnel added straps to the Stryker's tires (see fig 6) to reduce the movement and prevent damage to the other equipment and the vessel.

c. The vessel slamming also caused some of the other equipment such as the HMMWVs to move vertically. The vertical movement of this equipment was due to the types of lashing restraints and the tiedown procedures that were used. Tiedowns should reduce the normal height of a vehicle between 1 and 3 inches. This reduction did not take place during this exercise because of the inadequate lashing gear and vessel tiedown strength.

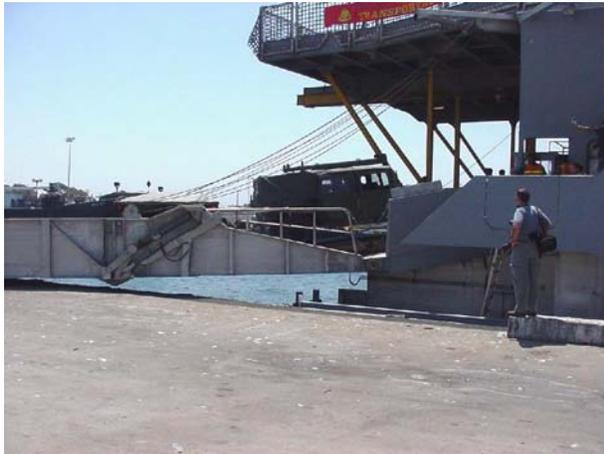
Figure 7. Ramp at High Tide

b. Ramp. During the onload, the tidal conditions were at a point where the quarter stern ramp was positioned evenly with the apron and the vessel entrance (fig 7). If the tide were lower, then the ramp would have hit the apron and the ramp would have to be adjusted to avoid contact with the apron. The ramp at low tide is shown in figure 8. This configuration requires the use of wooden inserts in the forward ramp joint to load vehicles. The quarter stern ramp should be redesigned to automatically adjust to aprons of various heights and tidal conditions without using wooden inserts.
